MERRIMACK RIVER BASIN
BRADFORD, NEW HAMPSHIRE

TODD LAKE DAM

NH 00288

PHASE I INSPECTION REPORT
NATIONAL DAM INSPECTION PROGRAM

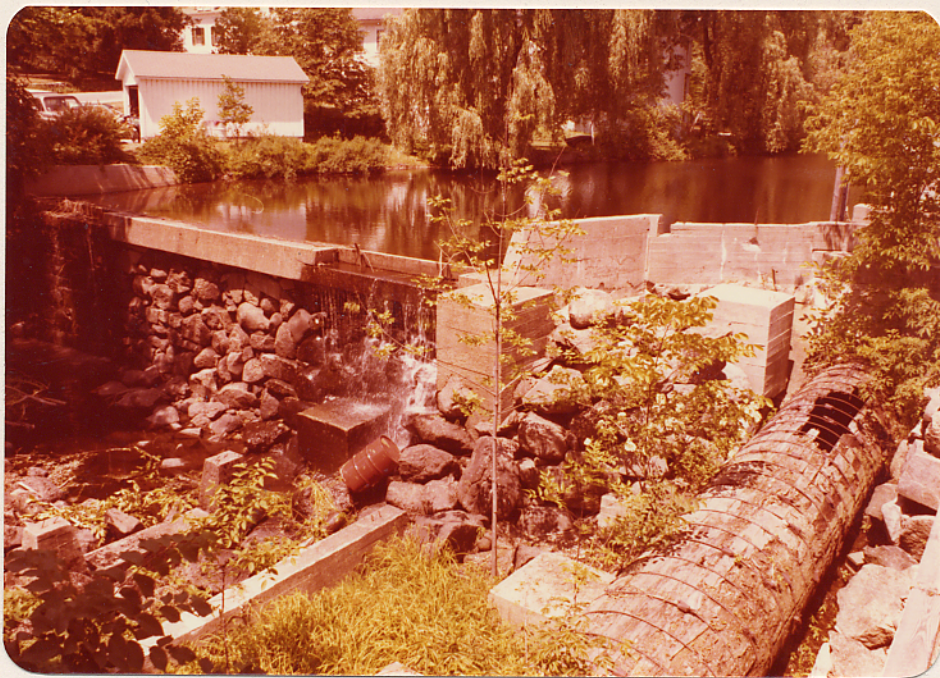
Overview from left side downstream (8 July 78)

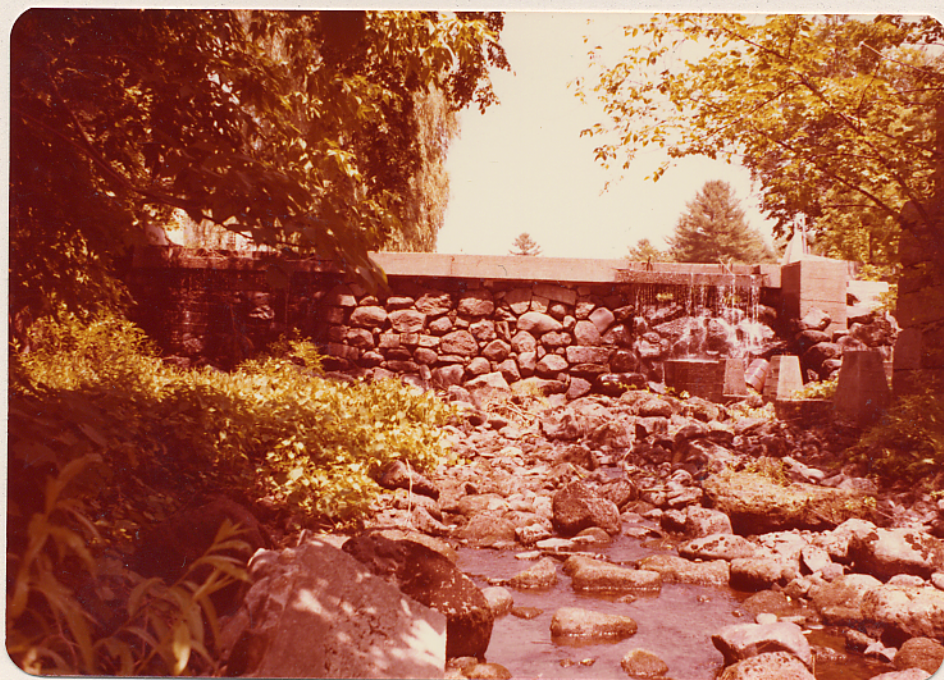
Overview from downstream channel (8 July 78)

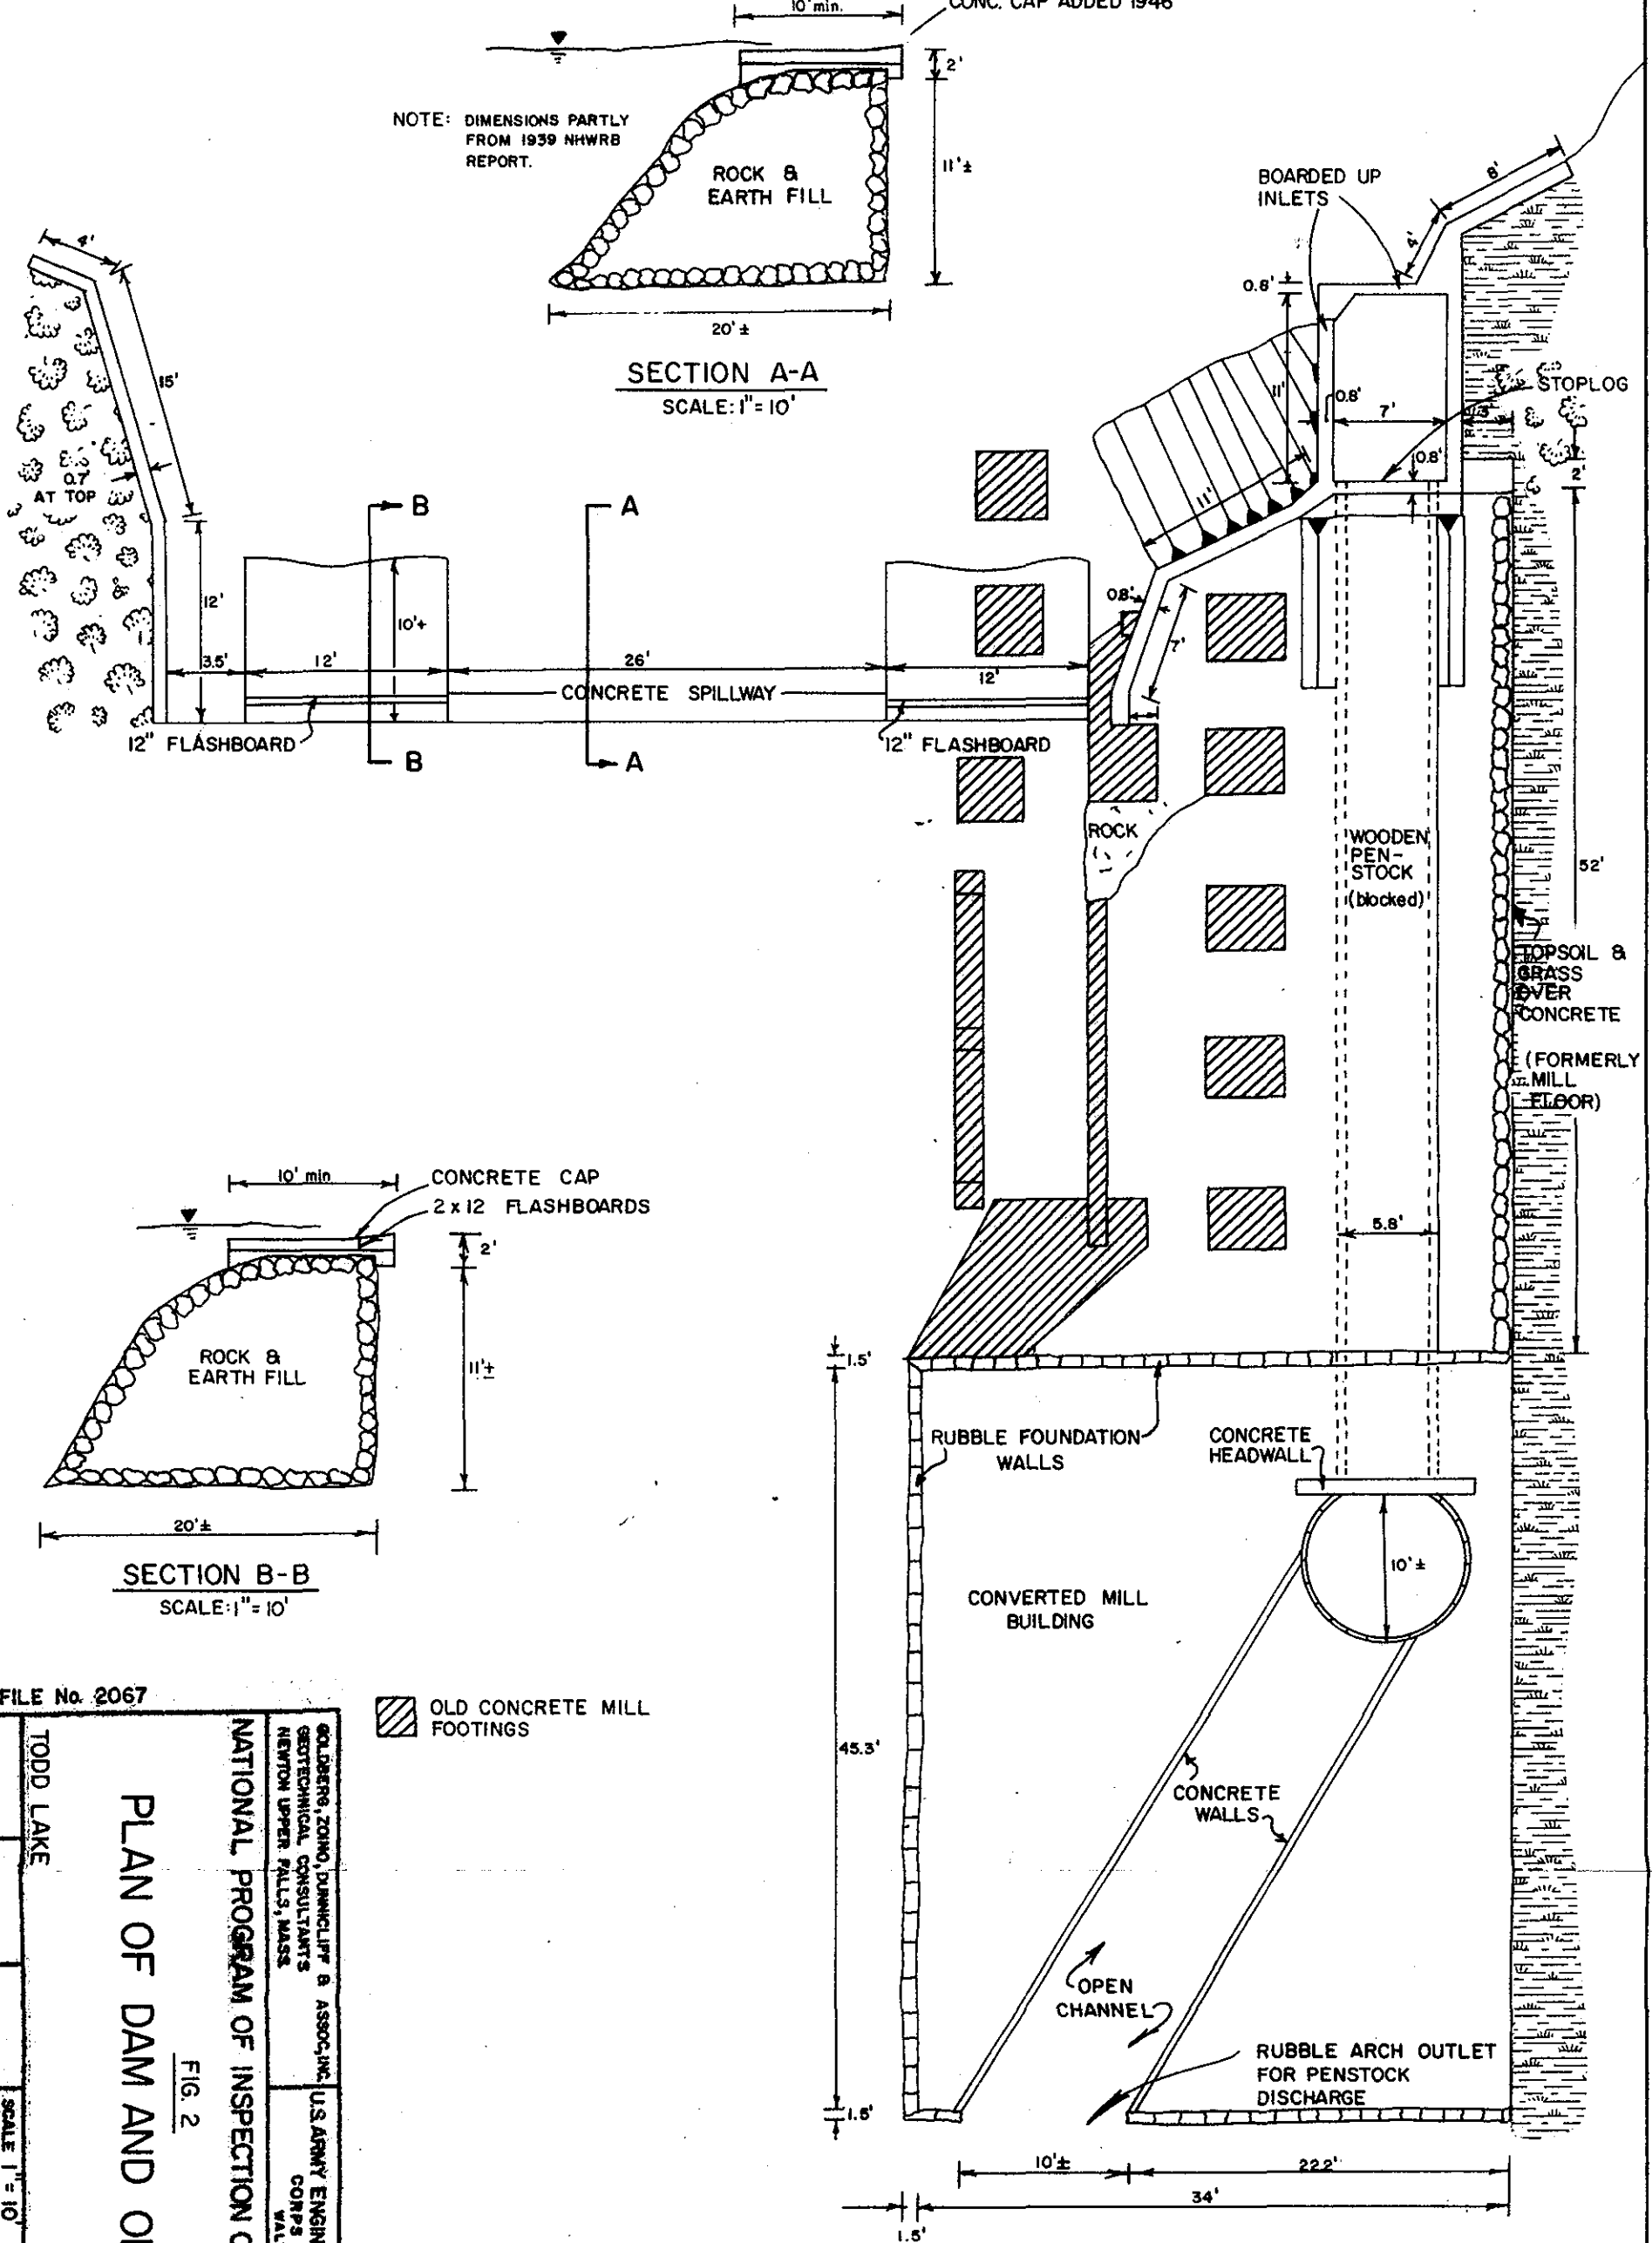
FIG. 2

The dam consists essentially of a gravity rock wall and earth fill structure with a base width estimated at 20 feet and a maximum height of 16.5 ft. (Figure 2). A concrete spillway covers the gravity structure over its entire 57 foot length and has two 12 foot long depressed sections, one near each end, which permit the installation of 12 inch flashboards (Figure 2). The left abutment incorporates the dam's outlet works which consist of a concrete box with two inlets and one outlet. Stop-logs at one time regulated flow through the outlet which then led into a now boarded up 5.8 foot diameter wooden penstock (Figure 3). The previous owner has sealed both inlets, probably by boarding, one of which is on the right side. No special hazard is believed to attend the penstock. The outlet works originally provided flow for the operation of a saw mill complex, only part of which remains today, having been converted into a one family home. Old concrete footings for the mill buildings still exist around the dam. The wooden penstock runs into the converted mill building, as does the small amount of water which leaks through the boarded up outlet works. A concrete lined channel carries this flow under the house. A concrete arch bridge permits flow under old Route 103 approximately 100 feet downstream of the dam.

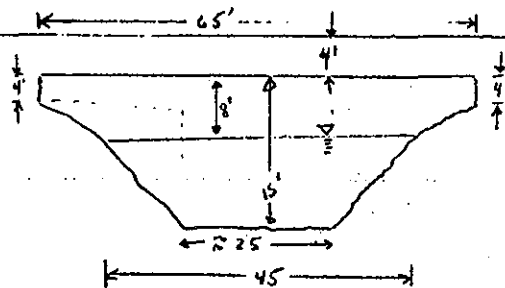
SOME CONSIDERATION MUST BE GIVEN TO WHETHER OR NOT THE NEW RITE 103 HIGHWAY EMBANKMENT WHICH FOLLOWS THE ALIGNMENT OF THE OLD RAILROAD WILL SERVE AS A DAM AND THUS REDUCE THE PEAK FLOW THAT REACHES THE TODD LAKE DAM. A CROSS SECTION AT THE HIGHWAY BRIDGE WAS TAKEN ON 7/12/78.

GIVEN THE LARGE OPENING $\approx 750 \text{ FT}^2$ AND THE LIMITED FREEBOARD ONCE THE BRIDGE GOES TO PRESSURE FLOW, IT IS UNLIKELY THAT A SIGNIFICANT REDUCTION IN FLOW WOULD RESULT FROM THE BRIDGE.
